FINAL REPORT

Spring Mission: March 20, 2012 – April 25, 2012

“Conservation and Documentation of the Wall Paintings at the Red Monastery, Sohag”

Sub-grant No. EAC-34-2012

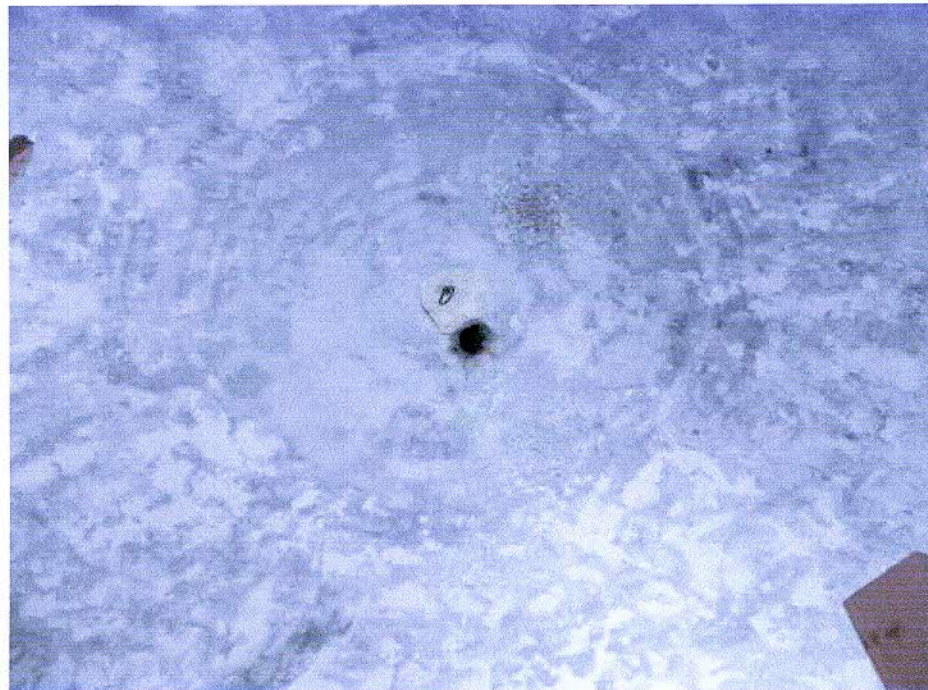
Figure 22

The east lobe suffered from structural instability at some stage in antiquity, resulting in cracks and falls of plaster as well as the collapse of the entire upper part of the clerestory and central dome. The causes and consequences of this instability were examined in the report for the Spring 2007 season⁶. Damage connected with these events can be seen throughout the building, on the plaster and paintings in the lowest tier of the east lobe, all over the wall containing the triumphal arch and throughout the upper part of the building. As previously described, the whole upper part of the clerestory suffered a serious collapse as the result of a severe earthquake and the entire area surrounding the triumphal entrance arch was tilted several degrees towards the nave (west). At the start of the twentieth century, restoration work undertaken by the Comité resulted in the structural consolidation of the Sanctuary in its entirety, the rebuilding of the triumphal arch with new stone blocks and the reconstruction of the clerestory with fired bricks and the dome with perforated bricks. All reconstructed areas were plastered with a yellow mortar rich in sand but containing little lime, then finished with a fine gypsum-based plaster (Figure 22).

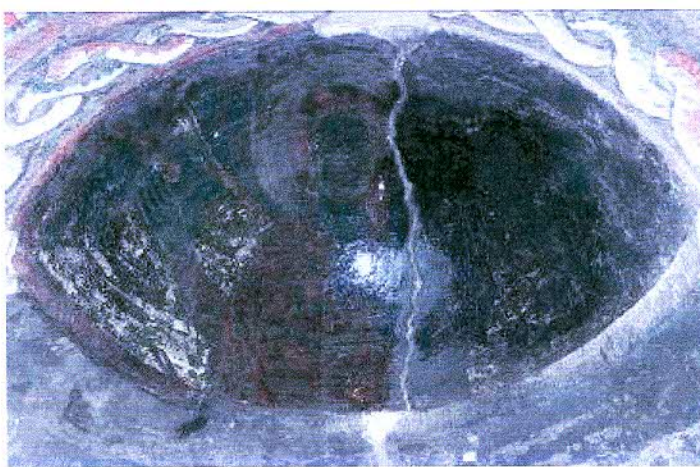
Figure 23

In spite of the Comité's work, numerous signs of the serious structural problems afflicting the church remain in the form of the extensive loss of portions of plaster and deep cracks whose opposing planes are often out of alignment (Figure 23).

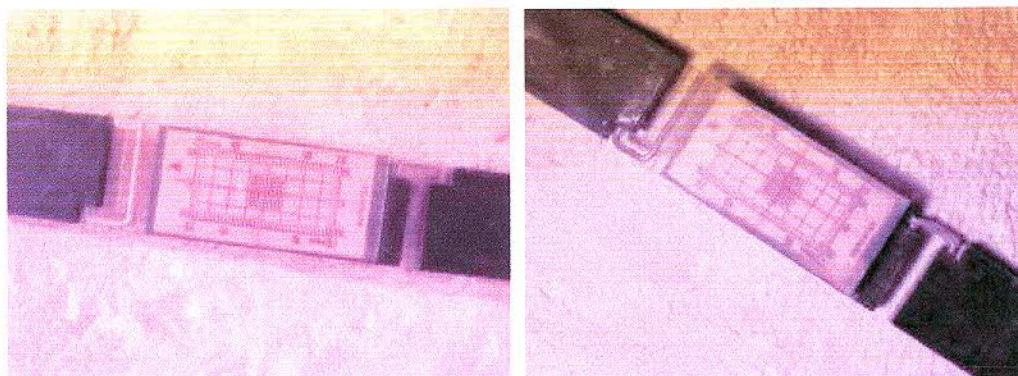
Figures 24 and 25

Two crack monitors were installed above the triumphal access arch at the beginning of the project in order to monitor new structural movements in the building. They were removed in April 2012 since no new movement or settling of the building had been registered for four years (Figures 24 and 25).

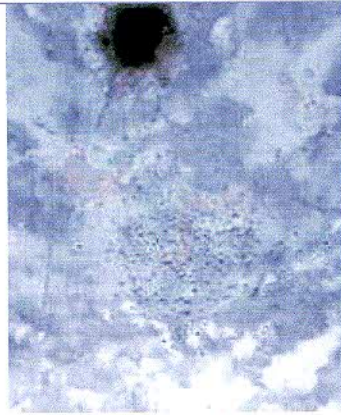
Figure 28

Finally, the grayish plaster finish of the central dome proved to be in a poor state of preservation, to the extent that it even bears the marks of shotgun pellets (Figure 28).

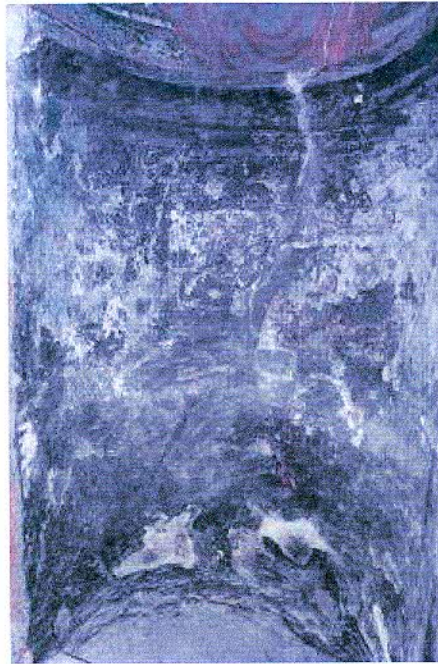
Figure 29

The central niche of the east lobe (lowest tier) is heavily soot-blackened as a result of its intensive use during religious services, especially since the iconostasis was moved back to the threshold of the conch, thereby confining the Sanctuary of the church to this small area. This led to the continuous use of the base of the niche as a shelf for oil lamps and candles with grave consequences for all the internal surfaces.

The blackening of the paintings inside the niche made it impossible to decipher their subjects. Furthermore, part of the surface in the center was painted with a fine layer of modern white wash that almost entirely obliterated the image (Figure 29).

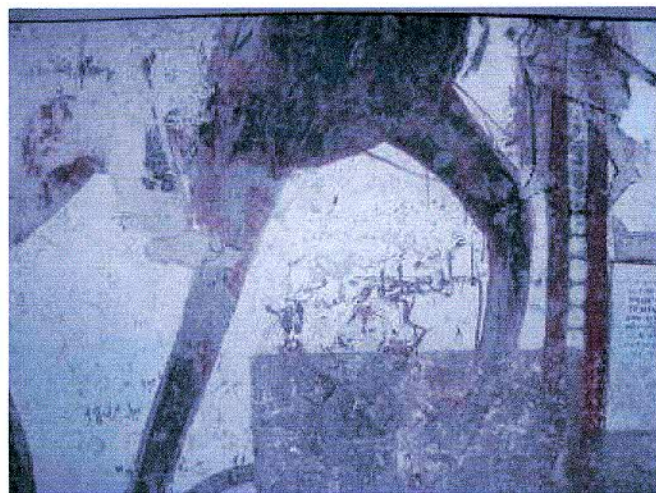
Figure 30

Both the cross and the Saint on Horseback on the north wall of the facade were heavily abraded as a result of exposure to the elements for an indeterminate period (Figure 30).

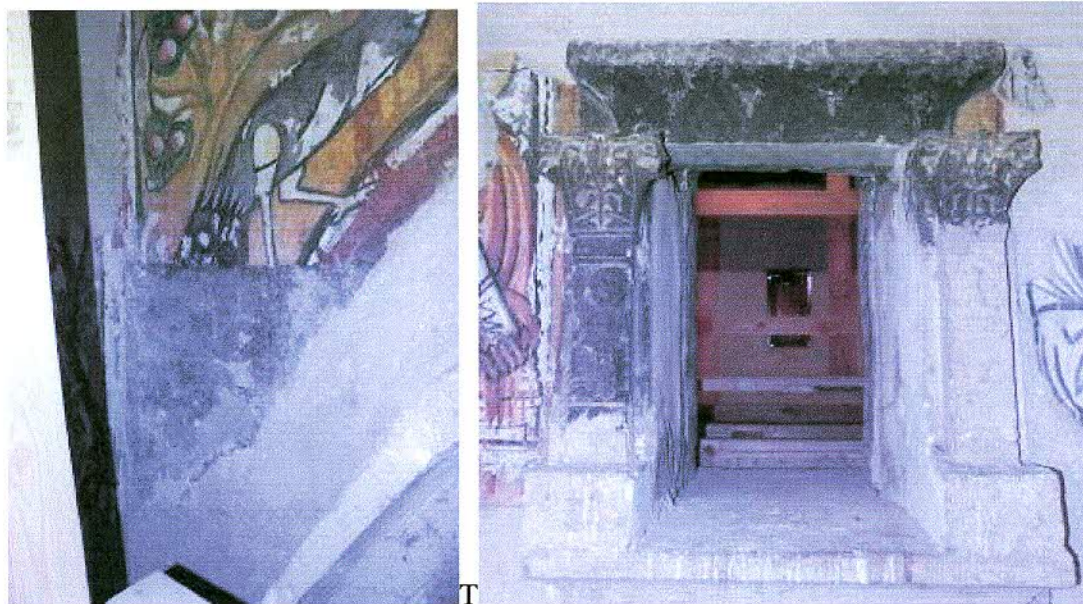
Figures 31 and 32

As already mentioned, there are only a few painted fragments on the west side of the clerestory. The existing paintings are covered with a thick deposit of dust and partially consolidated and unconsolidated particulate matter (Figures 31 and 32). The paintings of the peacocks, together with the painted stonework of the small central window, were damaged by wind erosion and the wetting and weakening of the paint layer so that it became detached from the plaster and tiny fragments were lost. This damage is consistent with the prolonged exposure of this tier to the elements as a result of the absence of windows and roof for a long period of time. The white wash of the fourth phase has mostly fallen off revealing the peacocks flanking the stone arch almost in their entirety.

The extensive plaster loss was caused by the poor adhesion of the whitewash to the third-phase wax-painted surface (especially the jarosite backgrounds painted using the encaustic method).
